Investigation of Construction Failure of Reinforced Concrete Cooling Tower at Cow Island, WV

Investigation of Construction Failure of Reinforced Concrete Cooling Tower at Willow Island, WV

An investigation of the construction failure of the natural-draft concrete cooling tower at Willow Island, West Virginia on April 27, 1978 was carried out by the National Bureau of Standards (NBS) at the request of the Occupational Safety and Health Administration (OSHA), the Department of Labor. This investigation was conducted pursuant to an interagency agreement between OSHA and NBS.

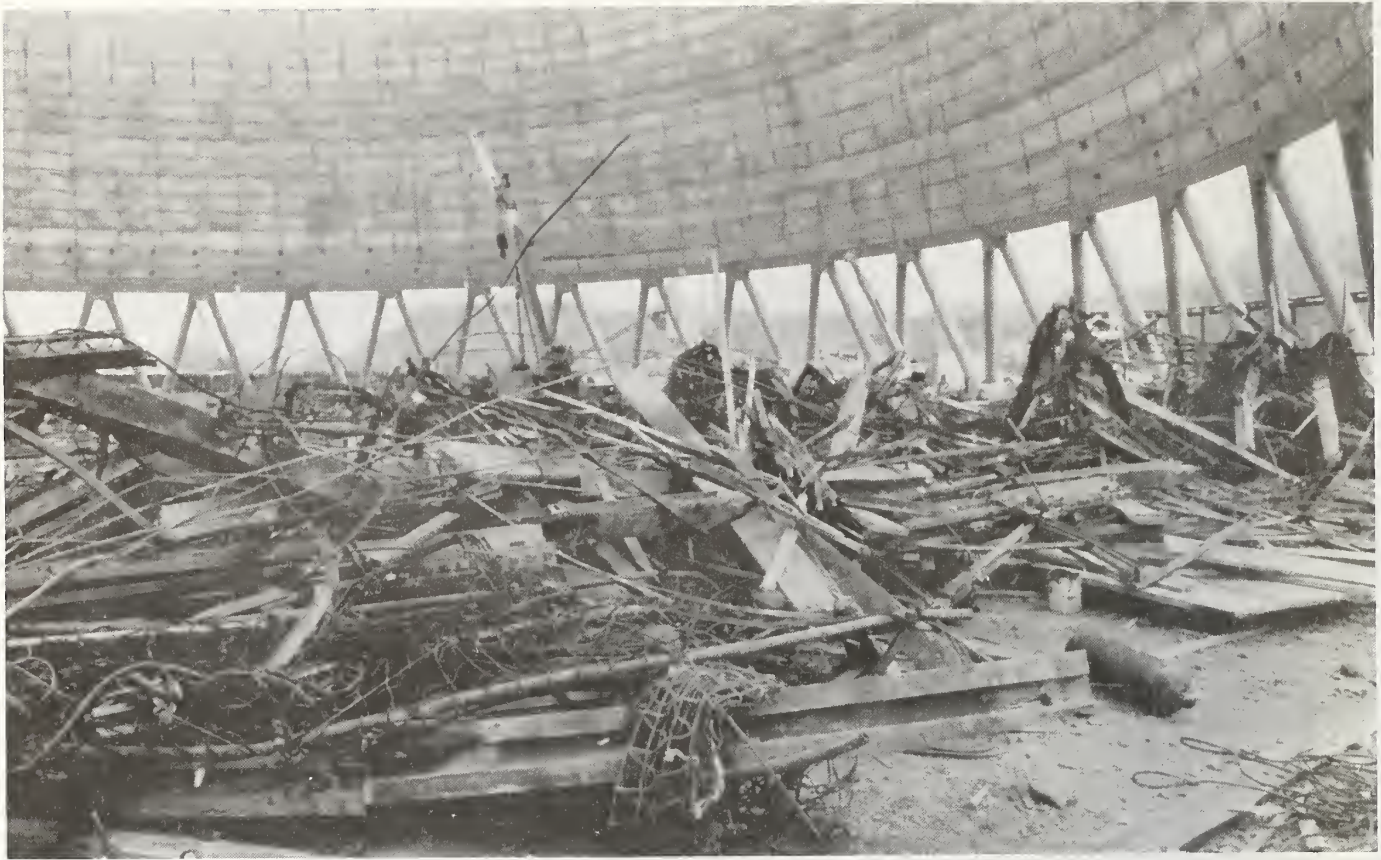
Figure 3.3 Debris Piled up Inside the Tower

Figures 3.3 and 3.4 show debris piled upon the floor of the tower around the base perimeter. While the general positions of the debris inside the tower have not been drastically changed, it is known that the debris was lifted and moved to some extent during the rescue operations. The debris mainly consists of the cathead gantries, scaffolding and formwork systems, safety nets, and equipment. The concrete of lift 28 apparently pulverized upon impacting the tower floor since no large pieces of broken concrete were found.

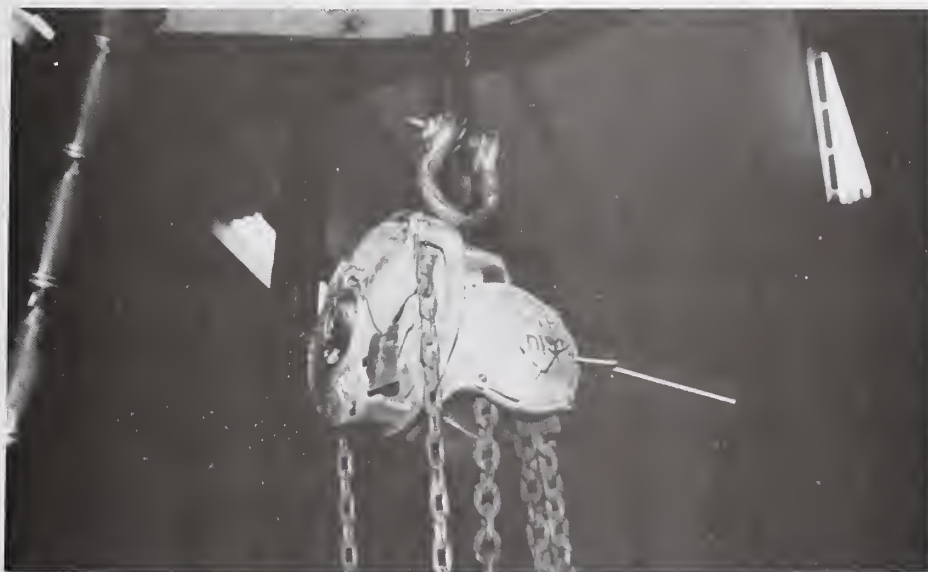
Figure 4.14 Fractured Cover Plate for Gear Box

The test setup shown in figure 4.13 duplicates the field condition using the cable slings and clevises of cathead no. 4. When the test load reached 15,310 lb (68.1 kN), the internal gear system fractured without the chain slipping. The fracture of the gear system also shattered the cover plate of the housing of the chain hoist (figure 4.14).

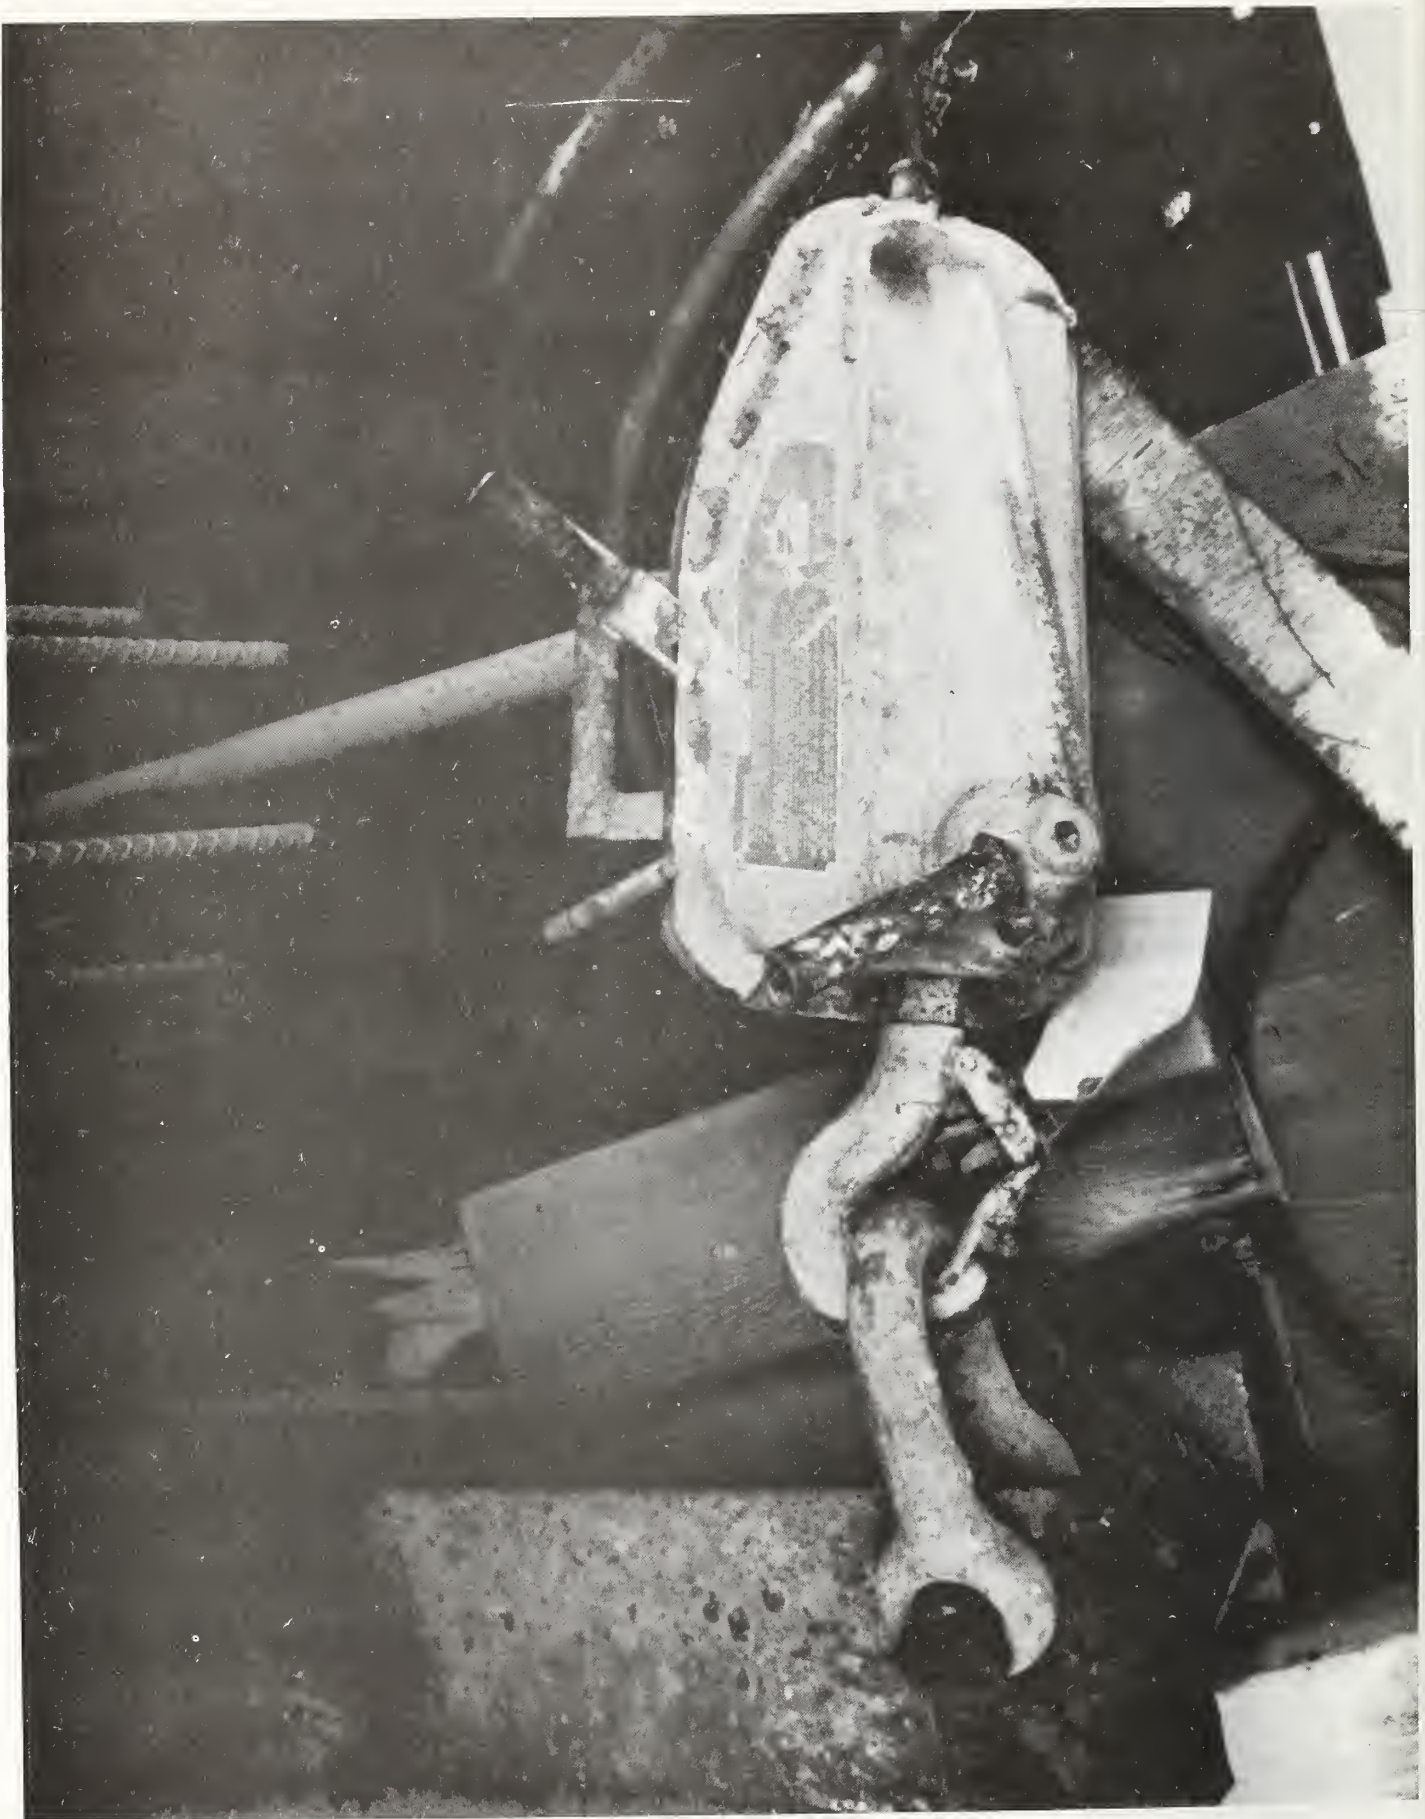
Figure 4.15 Anchorage of static line to ground through grip-hoist

As shown in figure 4.15, the static line was anchored to the ground by means of a grip-hoist. By jacking the hand lever on the grip-hoist, the static cable length and tension could be adjusted. Because any slippage of the static line through the grip-hoist could cause cathead no. 4 to become unstable the grip-hoist capacity needed to be determined.
